Helicopters and bird strikes

Major Riku Paloniitty
Air Patrol Squadron

Rajavartiolaitos
Gränsbevakningsväsendet
The Finnish Border Guard

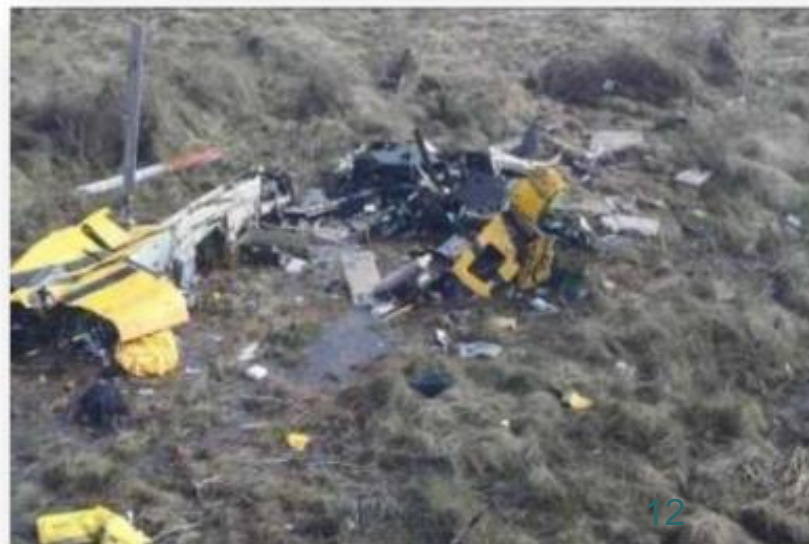
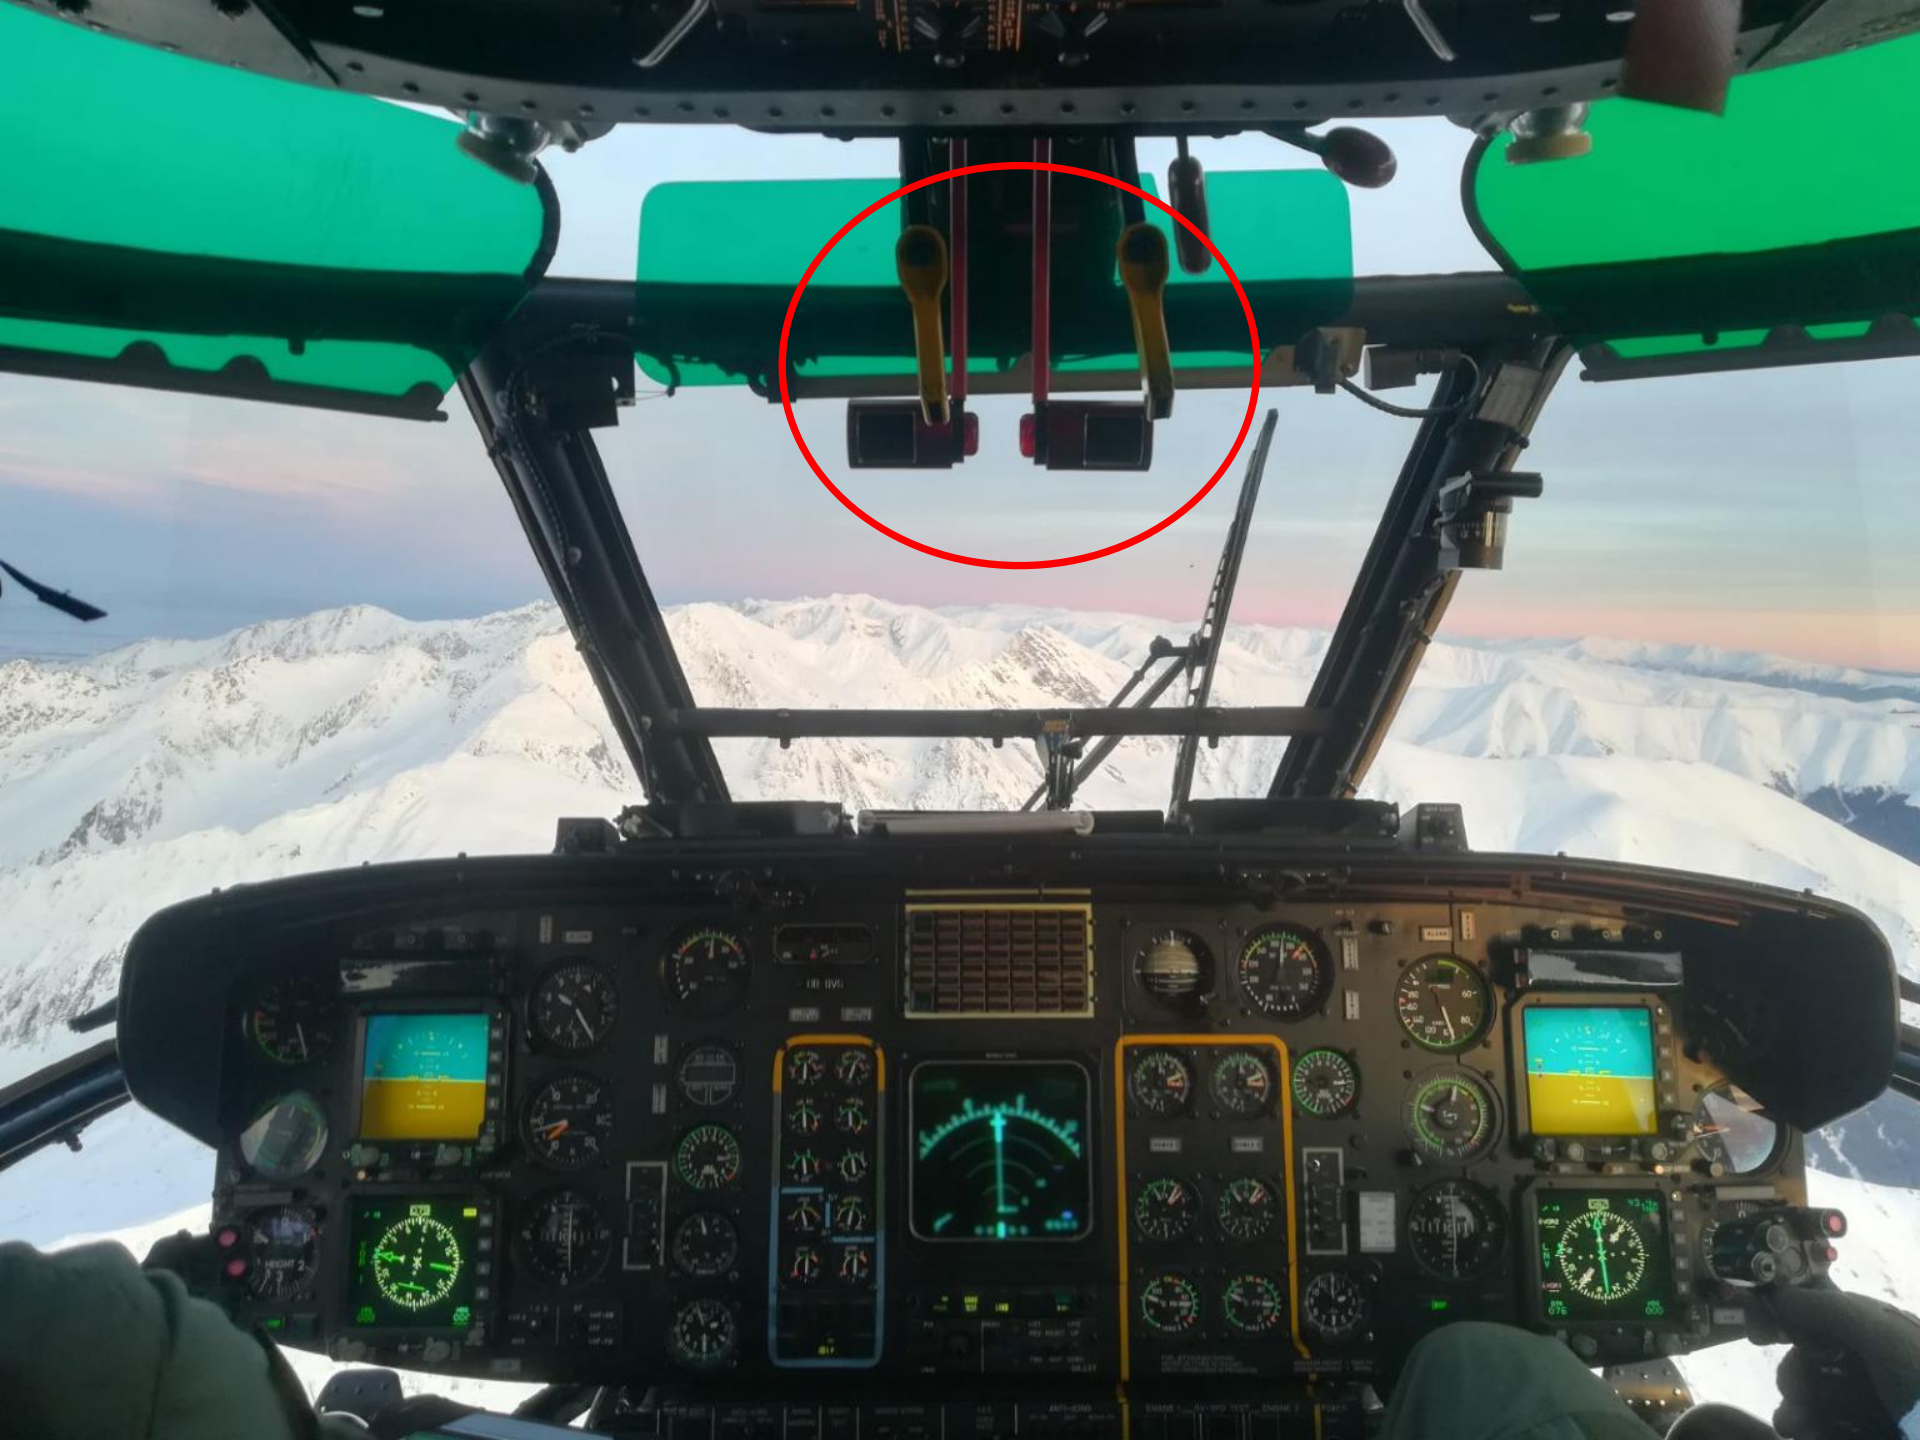
4th Jan 2009: Sikorsky S-76C++ helicopter (N748P) crash (Louisiana), 8 fatalities.

A Red-tailed hawk of 1.1kg/2.4lbs fractured the windshield and interfered with engine fuel controls causing a sudden loss of power to both engines.

- Windshield not certified to bird strike requirement
- Lack of protections on engine fuel control handles.
- Lack of a warning system to alert the flight crew of a low-rotor-speed condition.
- Lack of flight crew training for simultaneous dual-engine failure.

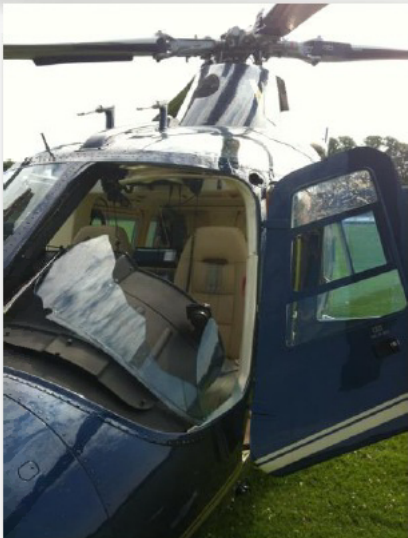
5th July 2011-A109C left windshield shattered by a Herring Gull (aw. 1.1kg/2.4lbs) impact. Pilot minor injuries. The co-pilot took control for an Emergency landing.

Windshield not certified to bird strike requirement

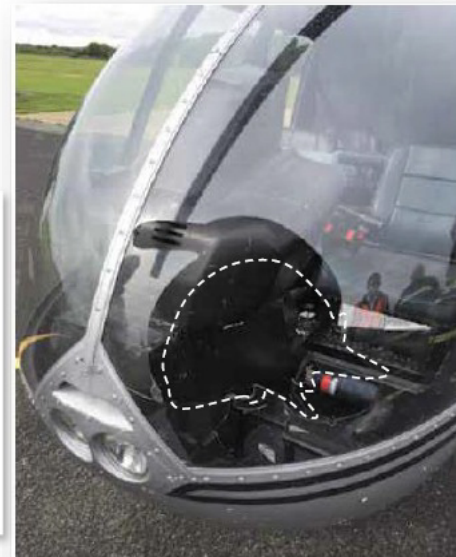
13th June 2016: Robinson R44, similar event.

The rotorcraft lost approximately 700ft in altitude whilst the crew dealt with the incident. They declared a MAYDAY and returned to base for an uneventful landing. No injury.

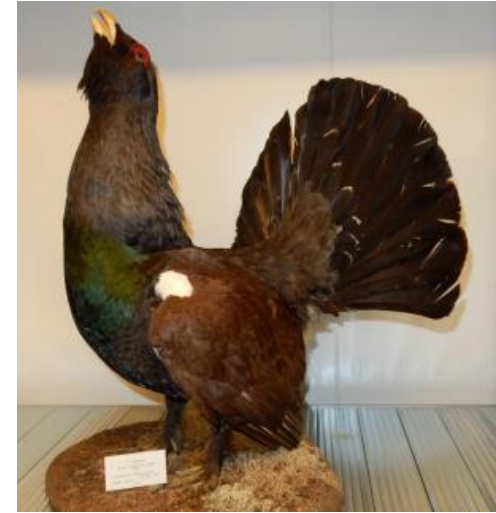
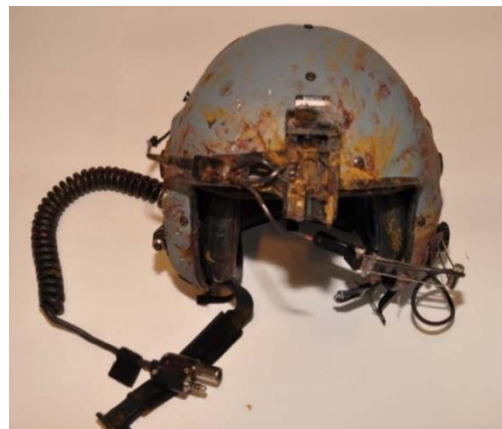
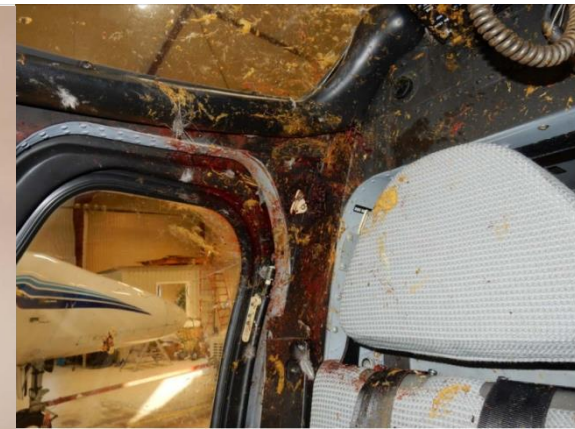
- Bird strike happened at 35ft, 100kts
- Wood grouse, apr. 4kg
- The helicopter's windshield and front door at right side were damaged
 - hit to the face of the student sitting RH seat – serious injuries
 - the helmet of the pilot was split partially
 - pilot has NVGs and eyeglasses, which were broken
- The instructor sitting LH seat were able to make landing
 - the other helicopter of the formation was able to pick up the injured pilot
