### **Pilot's report:**

**Excerpt from technicians' report:**

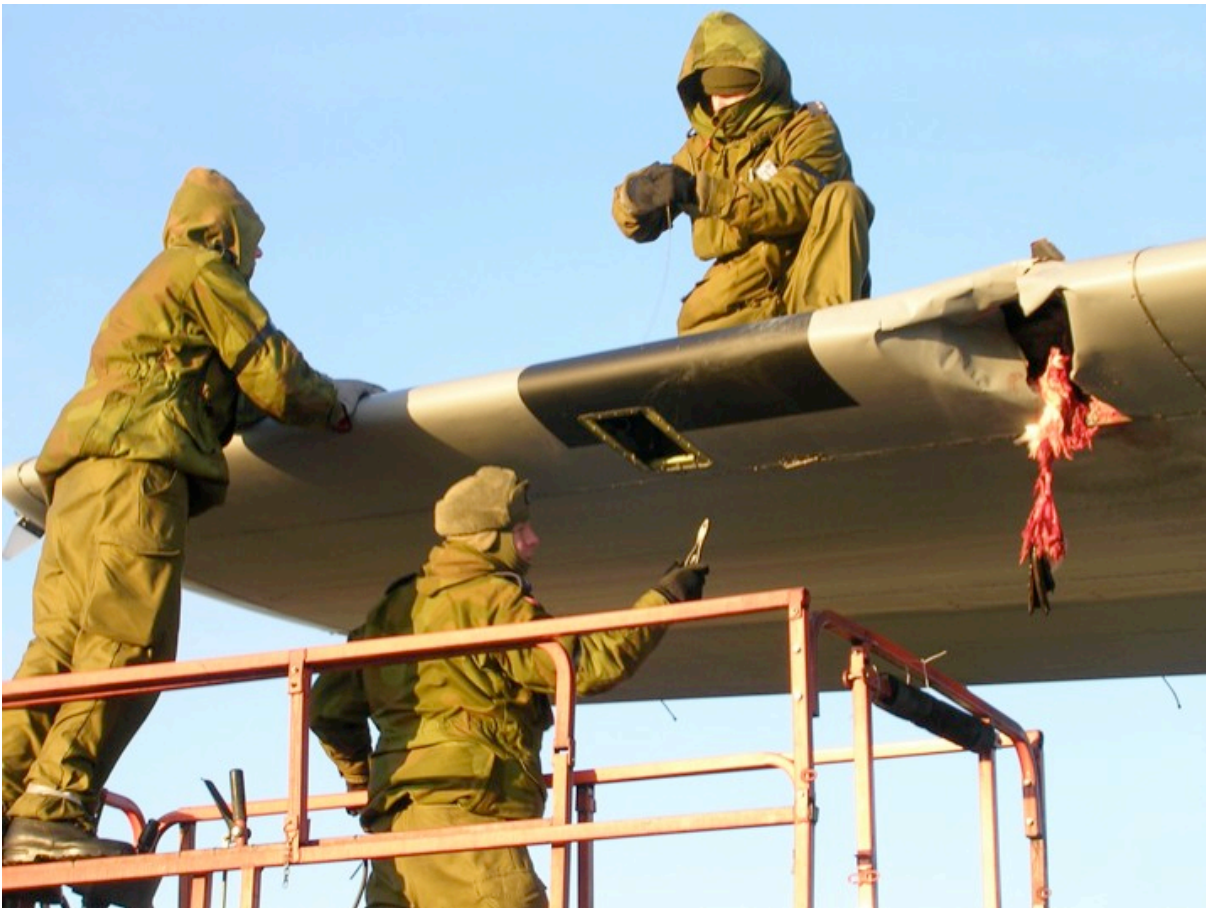
*Crew inspecting the aircraft after the birdstrike. Photo: Narve L. Skjærseth, The Norwegian Defence Logistics Organisation (NDLO)*

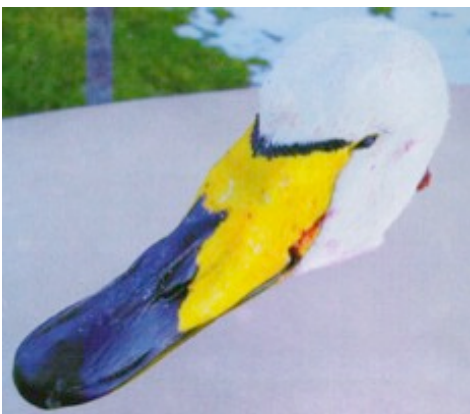
*The swan.  
Photo:  
Narve L.  
Skjærseth,  
NDLO*

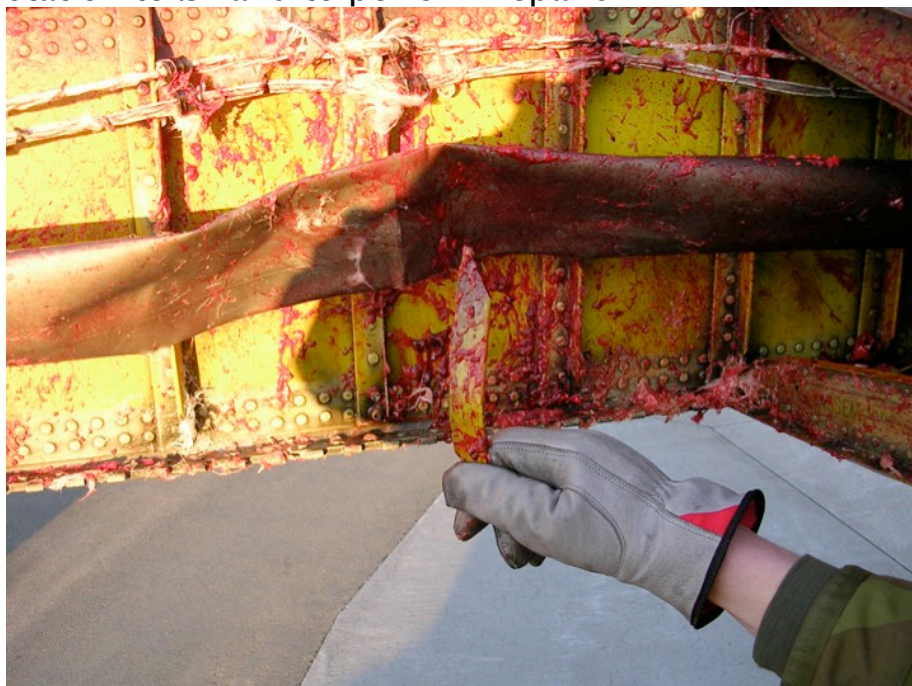
After landing the aircraft was inspected by maintenance personnel. A swan had penetrated the leading edge of the right wing outside of engine #4. Damage to the anti-icing ducts, structural stiffeners and fuel cell #4 were discovered. 3 structural stiffeners were deformed and cracked. #4 fuel cell wall was dented and ruptured. The sealing inside the fuel cell prevented a fuel leak. Quality assurance technicians inspected the aircraft. Their evaluation was that the aircraft was not cleared for ferry flight to home station for repairs. Maintenance personnel were deployed from home station to Ørland to perform repairs.

*Inside the wing after the birdstrike. Photos: Narve L. Skjærseth, NDLO*

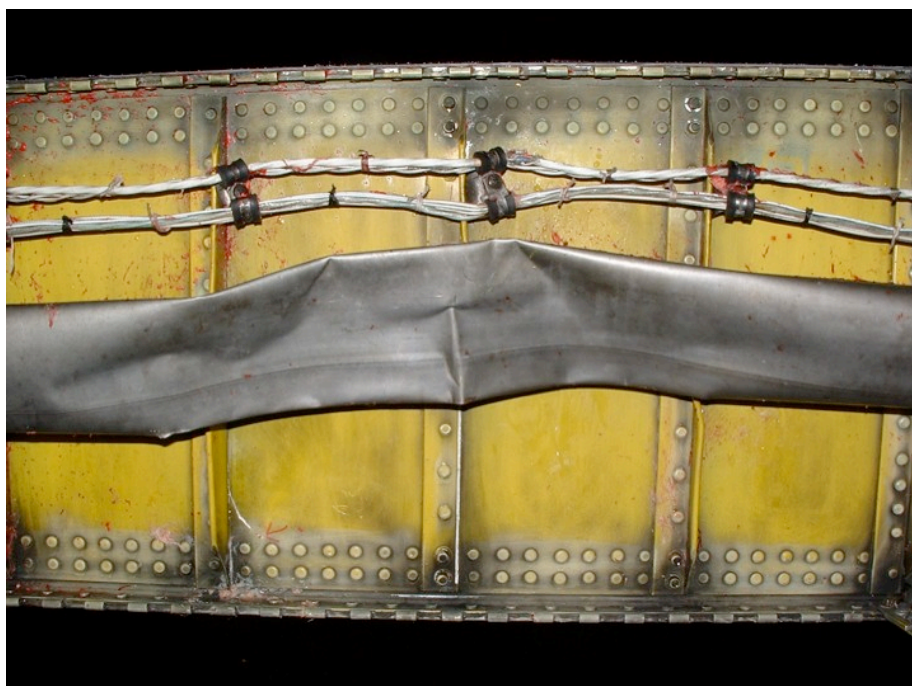
*Inside the wing after cleaning.*
