Helicopters and bird strikes

Major Riku Paloniitty
Air Patrol Squadron

Rajavartiolaitos
Gränsbevakningsväsendet
The Finnish Border Guard

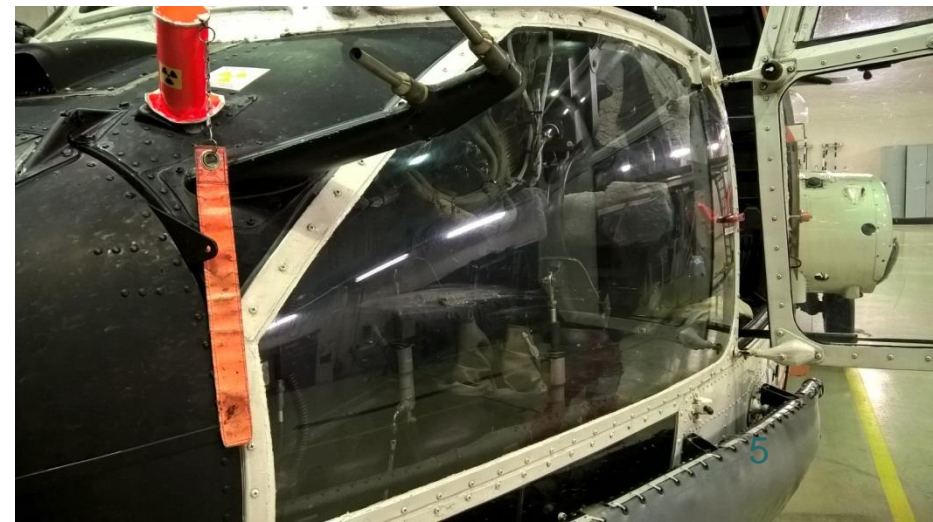
- After bird strike helicopter have to land for inspection
- No big damages

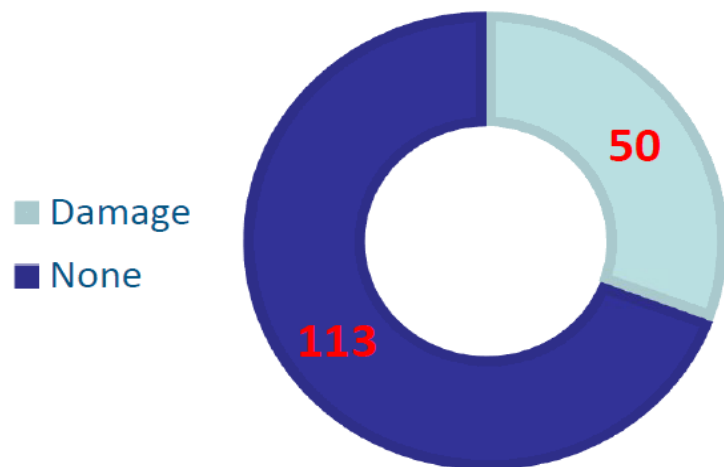
BIRD STRIKE DAMAGE OCCURENCES

Emergency landing	4.2%
Aborded take-off	3.0%
Mission aborded	11.5%
Precautionary landing	16.4%
Helicopter shut down for inspection	18.2%
None	46.7%

Small rotorcraft are more likely to suffer from damage compare to large rotorcraft (even if not certified). In 3 cases, windshield vulnerability to bird strike has caused pilot incapacity due to minor injuries (co-pilot took control).

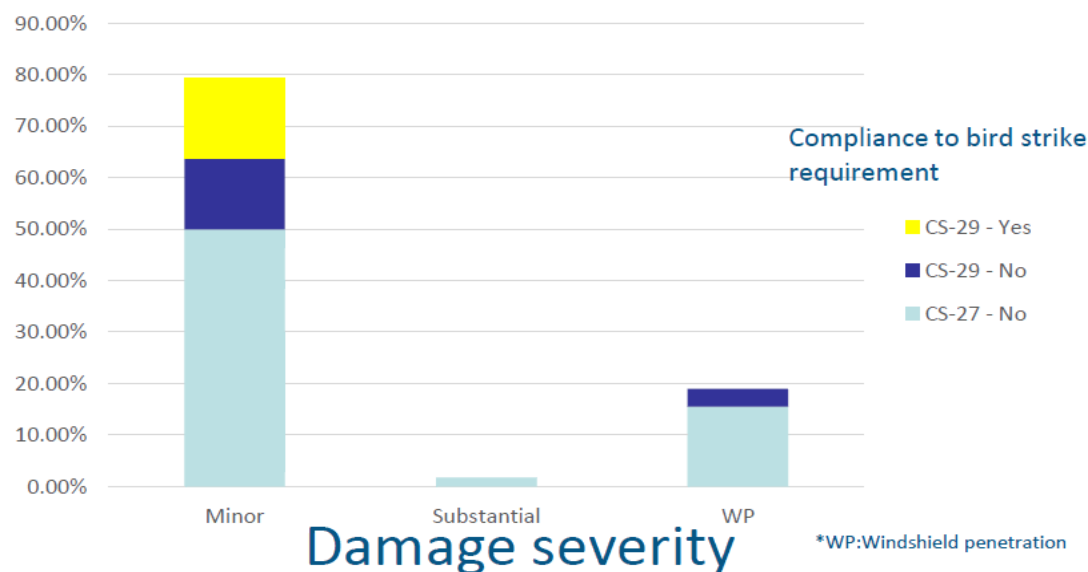
EASA database :Bird strike damage location and severity

Front Windshield	28%
Radome/nose/fuselage	20%
Main rotor	13%
Tail rotor/structure	5%
Others	34%

Bird strike impact have mainly caused minor damages aside from 2 substantial damages recorded (see definition ICAO annexe 13 in appendix).

Certified rotorcraft suffer from minor damages only.

On non-certified rotorcraft, when the front windshield is damaged, bird penetration occurs almost systematically (19 % of the damages).

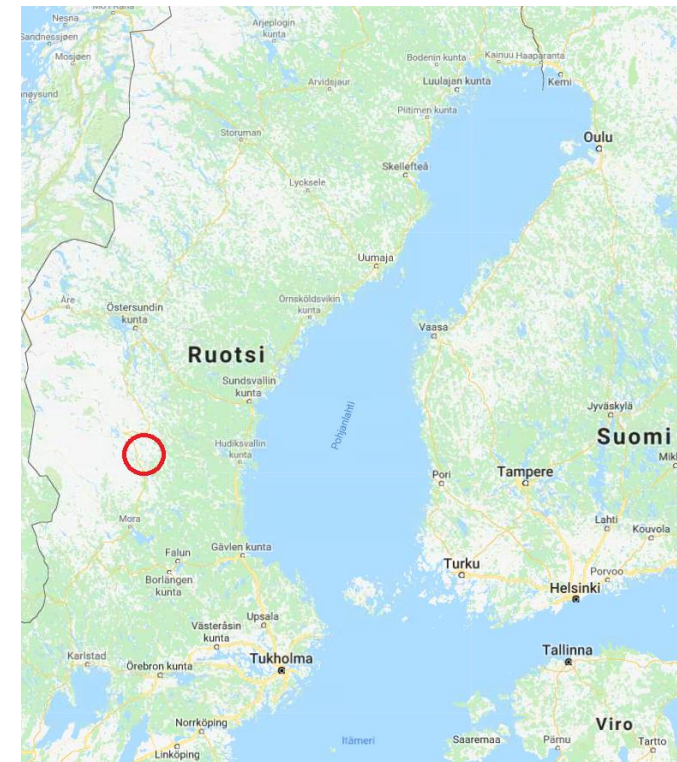
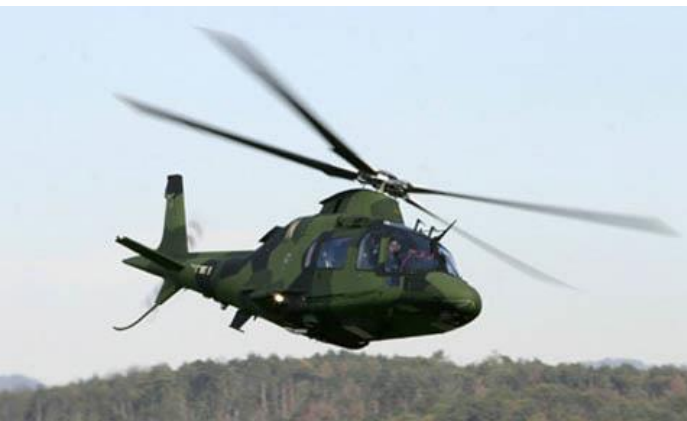
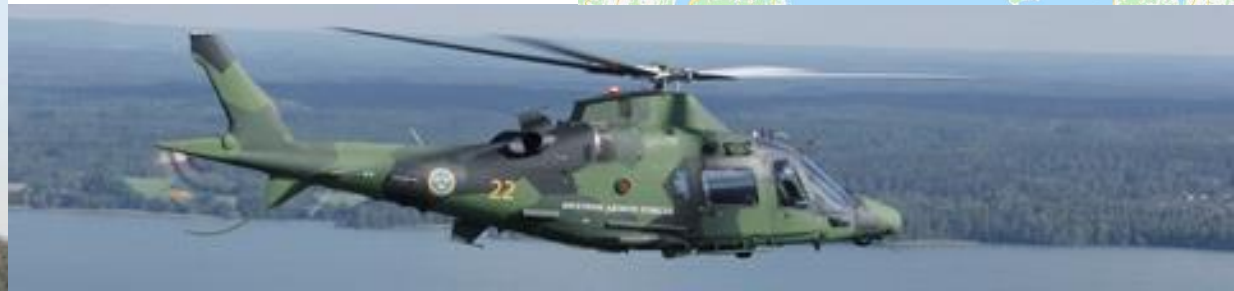
Case Sweden: Type and mission

- A109LUH (light utility helicopter)
- NVG, "nap-of-the-earth" –training flight
 - tactical flight at low altitude
 - 2 helicopters formation
- RH pilot (student) PF

- Bird strike happened at 35ft, 100kts
- Wood grouse, apr. 4kg
- The helicopter's windshield and front door at right side were damaged
 - hit to the face of the student sitting RH seat – serious injuries
 - the helmet of the pilot was split partially
 - pilot has NVGs and eyeglasses, which were broken
- The instructor sitting LH seat were able to make landing
 - the other helicopter of the formation was able to pick up the injured pilot
